### **#11: Explosion – Inspection #317706296**

A **42 year old male** employee died due to burns suffered during an explosion. Employees conducting furnace operations noticed steam coming from the electric arc furnace (EAF), and went to investigate. The two maintenance employees and four furnace operations employees tried to determine where the water was coming from and an explosion occurred. Most of the employees affected by the explosion walked away from the area with injuries, but one employee was burned over 55% of his body and received 3<sup>rd</sup> degree burns to his lungs. The employee was transported to the Vanderbilt burn center where he later died due to his injuries.

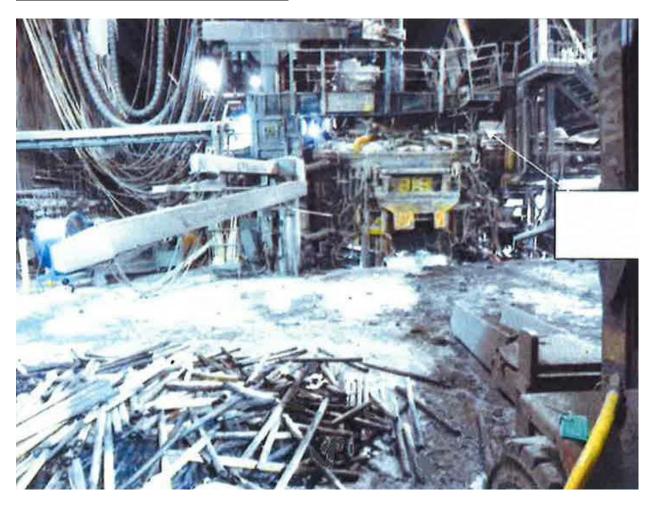
Photo 1 of 1: The white arrow points to where the victim was standing
